INFRASTRUCTURE COMMITTEE MEETING
6:00 p.m.

Monday, June 22, 2015
HAMPDEN TOWN OFFICE

To: Susan Lessard
From: Sean Currier
Subject: Existing manhole replacement in conjunction with new
sewer installation on Main Road N at Old County Road.

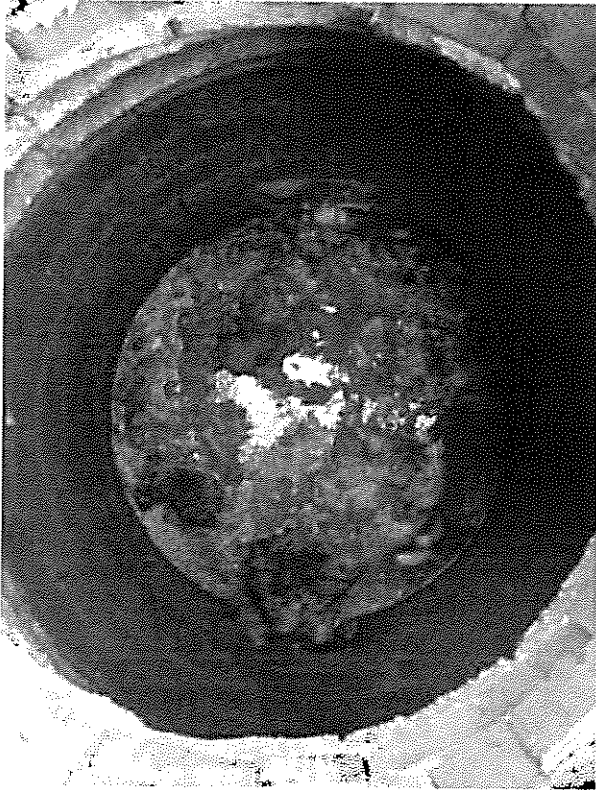
MH 91

It would be my recommendation to replace the existing, marginal condition, barrel block structures on both ends at the time of the sewer pipe renewal. The contractor will be digging pits to allow for pipe bursting regardless. In my opinion, it would be more cost effective and efficient for all parties to remove the existing structures and perform the pipe service as contracted, then install new precast concrete structures. A significant portion of the existing problem is no invert in the downstream structure, therefore causing material to backup and the sewer to surcharge and additional maintenance time by the Public Works crew.
